City of NORFOLK

Subject: Conveyance of property
located at 227 West Freemason
Street and 334 Duke Street to Virginia
Historic Restoration Foundation

U.S. Department of the Interior
National Park Service
Cultural Resources
Heritage Preservation Services

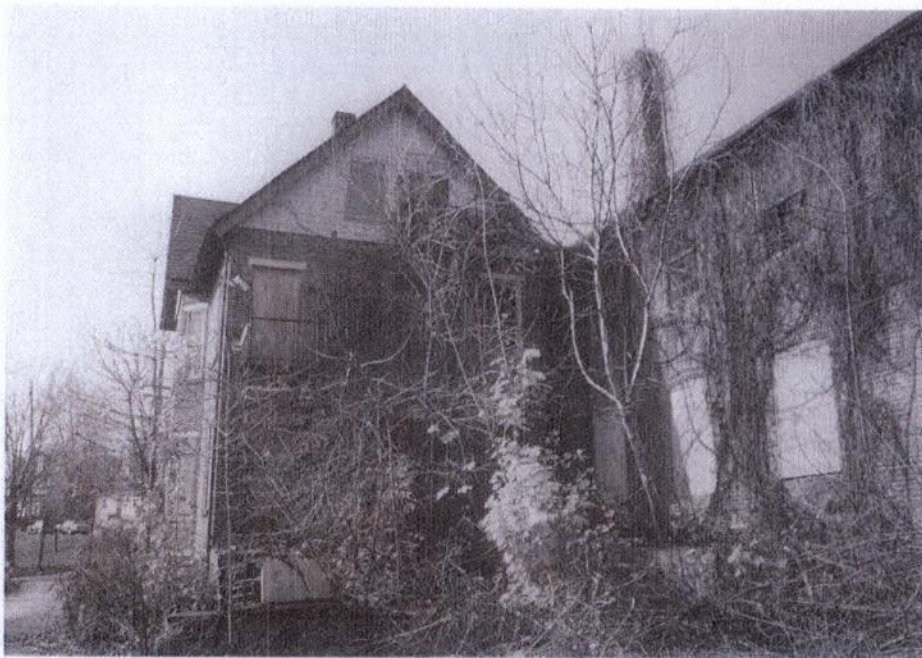
Figure 2. Improper treatment: Boarding up without adequate ventilation, lack of maintenance, and neglect of this property have accelerated deterioration. Photo; NPS file.

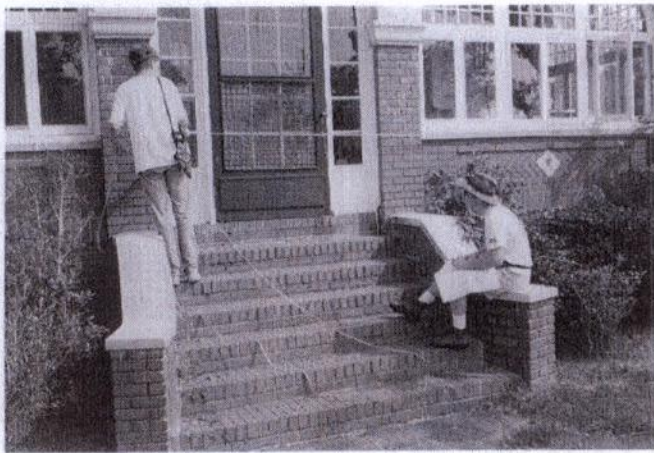
Figure 4. Documenting the building's history, preparing schematic plans, and assessing the condition of the building will provide necessary information on which to set priorities for stabilization and repair prior to securing the building. Photo: Frederick Lindstrom, HABS.

Old photographs can be helpful in identifying early or original features that might be hidden under modern materials. On a walk-through, the architect, historian, or preservation specialist should identify the architecturally significant elements of the building, both inside and out (see fig. 4).

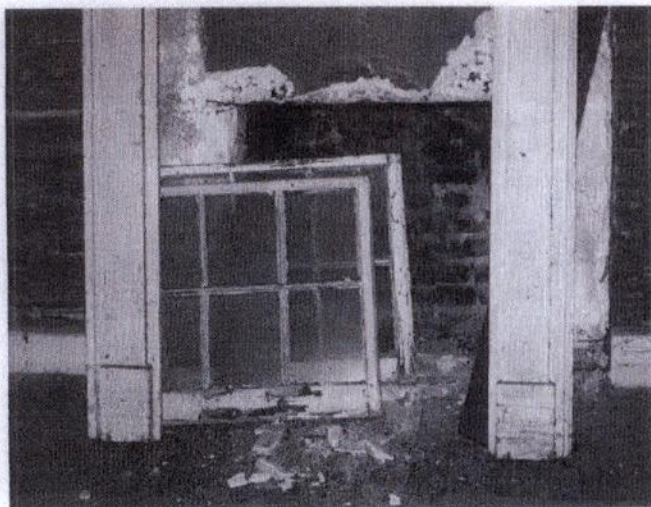
Figure 5. Loose or detached elements should be identified, tagged and stored, preferably on site. Photo: NPS files.

By understanding the history of the resource, significant elements, even though deteriorated, may be spared the trash pile. For that reason alone, any materials removed from the building or site as part of the stabilization effort should be carefully scrutinized and, if appearing historic, should be photographed, tagged with a number, inventoried, and safely stored, preferably in the building, for later retrieval (see fig. 5).

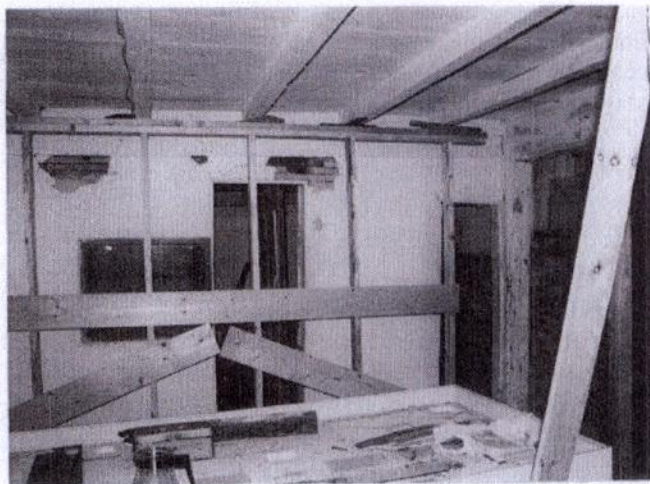
Figure 6. Interior bracing which will last the duration of the mothballing will protect weakened structural members. Jethro Coffin House. Photo: John Milner Architects.

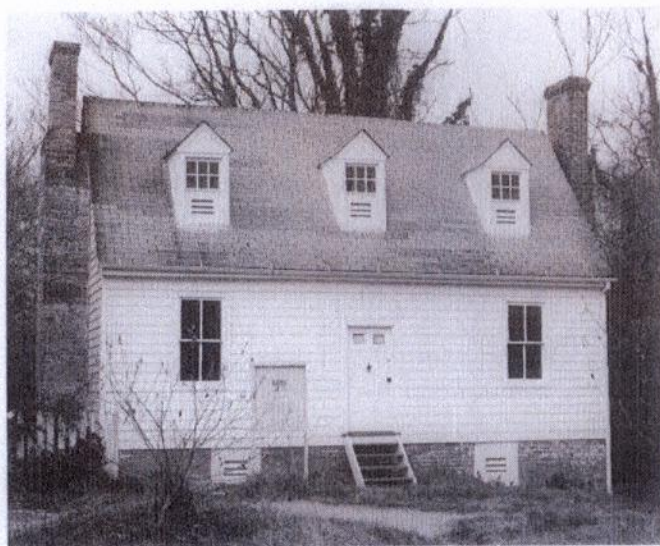
Figure 10. Regrading around the Booker Tenement at Colonial Williamsburg has protected the masonry foundation wall from excessive damp. This building has been successfully mothballed for over 10 years. Note the attic and basement vents, the temporary stairs, and the informative sign interpreting the history of this building.

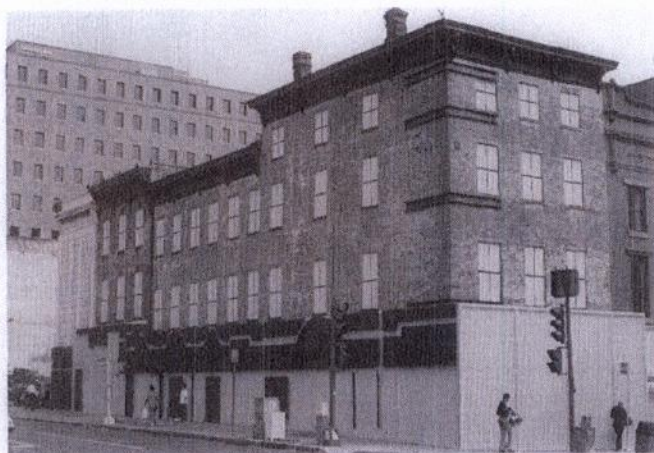
Figure 11. Urban buildings often need additional protection from unwanted entry and graffiti. This commercial building uses painted plywood panels to cover expansive glass storefronts and chain link fencing is applied on top of the panels. The upper windows on the street sides have been covered and painted to resemble 19th century sash. Photo: Thomas Jester, NPS.

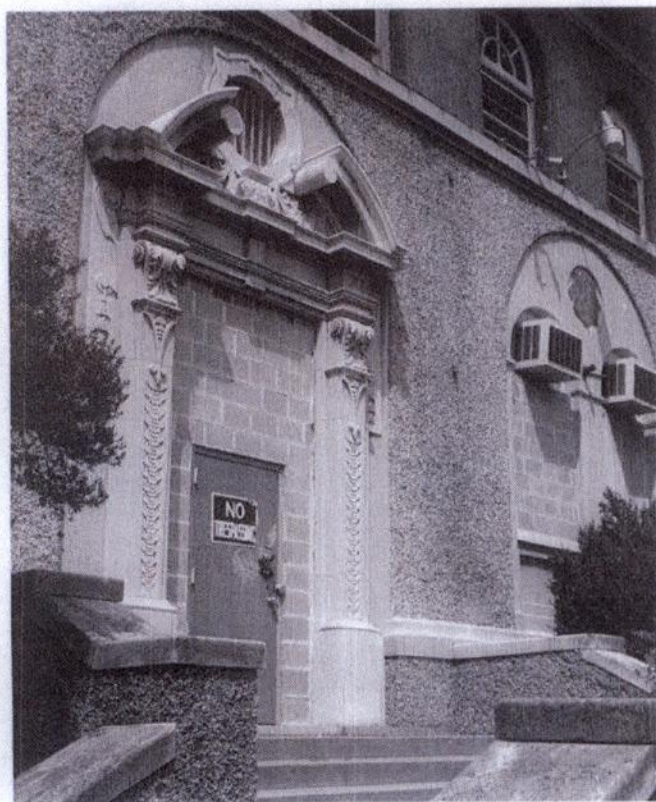
Figure 12. First floor openings have been filled with cinderblocks and doors, window sash and frames have been removed for safe keeping. Note the security light over the windows and the use of a security metal door with heavy duty locks. Photo: H. Ward Jandl, NPS.

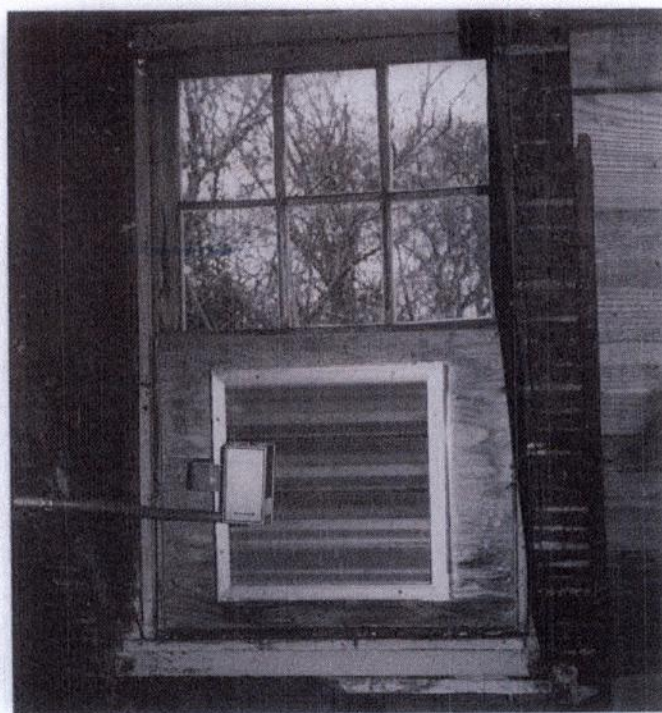
Figure 21. This electric thermostat/humidistat mounted in the attic vent controls a modified ducted air/fan system. The unit uses temporary exposed sheet metal ducts to pull air through the building and exhaust it out of the basement. For over ten years this fan system in combination with 18" x 18" preformed louvers in selective windows has kept the interior dry and with good air exchanges.

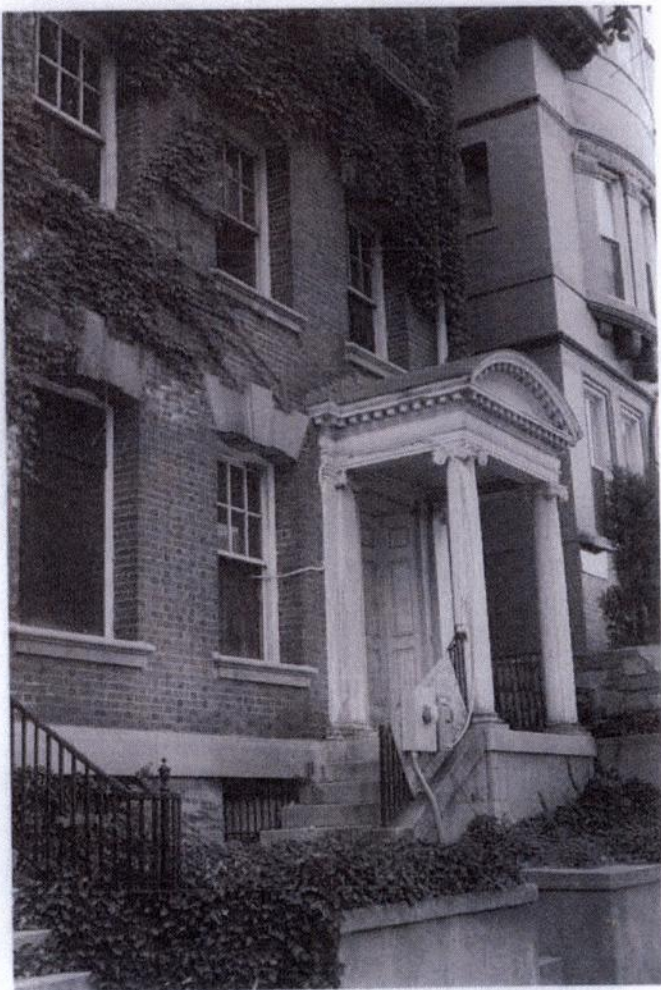
Figure 22. All systems except temporary electric have been shut off at this residence which has been mothballed over 20 years. An electric meter and 100 amp panel box have been set on a plywood panel at the front of the building. It is used for interior lighting and various alarm systems. The building, however, is showing signs of moisture problems with efflorescent stains on the masonry indicating the need for gutter maintenance and additional ventilation for the interior. The vegetation on the walls, although picturesque, traps moisture and is damaging to the masonry. Photo: H. Ward Jandl, NPS.

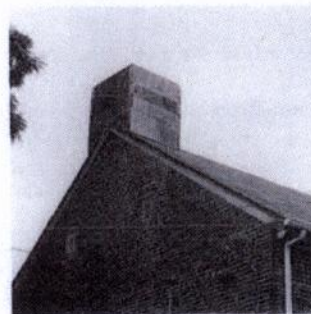
b. Plywood panels stabilize the chimneys. Note the gable vents.
